Procedure for installing the SanDevices UPG1 Upgrade Module when a Prop Programmer is not available.
Oct 26, 2012. Nov 17 2012

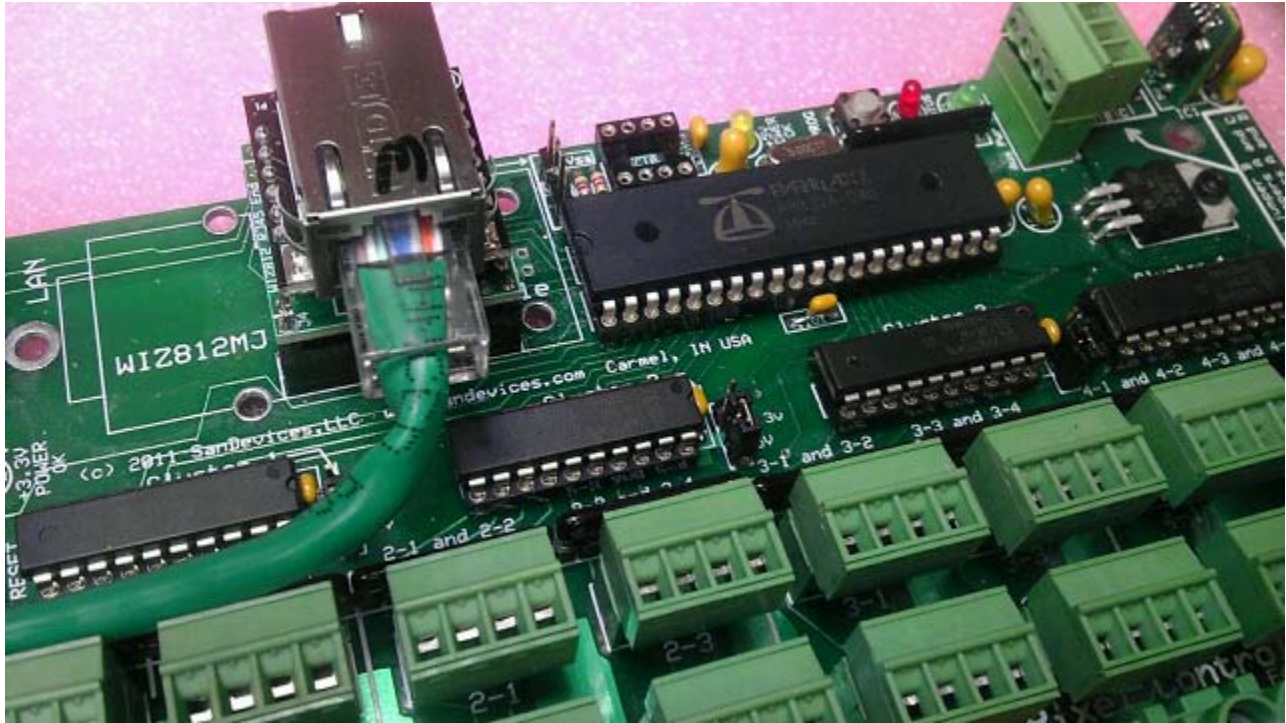
Unplug the old Ethernet module, and plug the UPG1 in its place. **IMPORTANT:** The UPG1 plugs in with the Ethernet connector facing towards the pixel connectors, in other words 90 degrees CCW from the previous direction. Make sure that the UPG1 is oriented in this direction, and make sure that the pins line up properly with the connectors on the board. Make sure your Ethernet cable is connected to the UPG1. You may want to use a “bootless” cable to make it easier to route the Ethernet cable clear of other components on the board.

If you are unable to access the web page after installing the UPG1 verify that the UPG1 is positioned correctly, that the Ethernet connector is pointing 'down', and that all of the UPG1 pins are lined up properly with the sockets. If you still can't access the configuration page, power down, put the old Ethernet module back in, power up and try the web page again. If successful it means that the firmware update failed, so please repeat the procedure.
